# Manhole Inspection Summary

Manhole # S11YY1009MH

**Location** Address: **5611 PIMILICO RD**

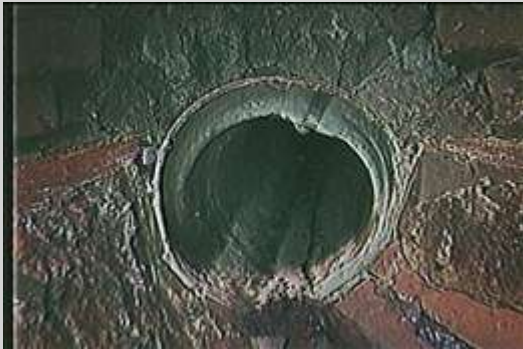
### 8 in. Circular Gravity Sewer Pipe Out @ 12 O'Clock

Pipe Material: **Unknown** ☒ Pipe Lined

Infiltration: **None** Pipe Seal Cond: **Unknown**
